Side Impact Upgrade Research Update

R&D Public Meeting
July 2002

National Highway Traffic Safety Administration

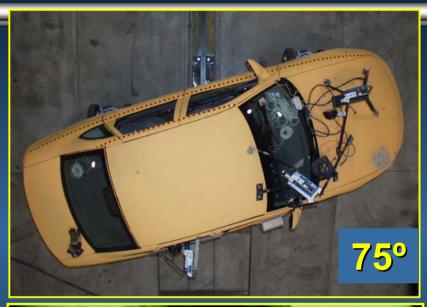
Research Pole Test Crash Conditions

- 20 mph: median total delta-v for seriously injured occupants (MAIS3+) in narrow objects side crashes
- 75° anticlockwise (Optional 201P is 90°)

Optional 201P	Oblique Pole Test
Angle	vehicle positioned 90° counterclockwise relative to line of motion	vehicle positioned 75° counterclockwise relative to line of motion
Alignment	centerline of 10"/254mm pole aligned with driver dummy head CG	centerline of 10"/254mm pole aligned with driver dummy head CG
Impact Speed	18 mph(29 km/h)	20 mph(32.2 km/h)

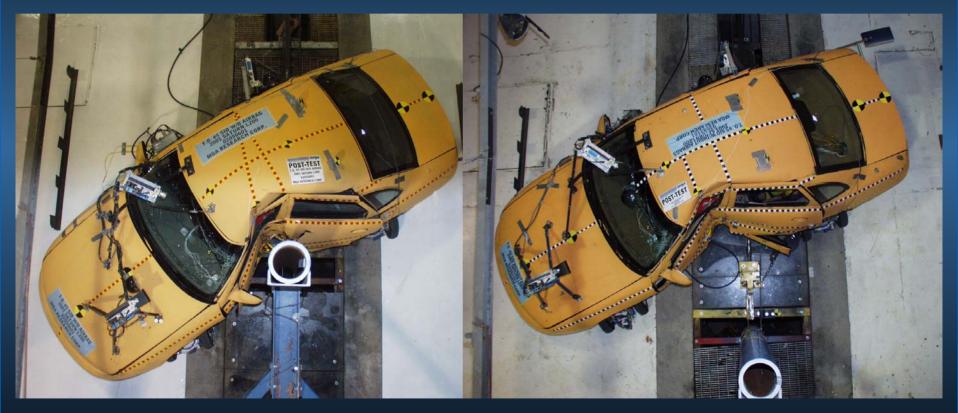
Post-Test Crush

75° oblique pole test: 20 mph Optional 201P test: 18 mph

- Representative of narrow object crash environment
- Repeatable
- Seating procedure <u>defined</u>
- 15% more energy in the lateral direction relative to Optional 201P test due to increase in speed from 18 to 20 mph
- More post test lateral crush than Optional 201P (about 4-5" or 10-13 cm)
